Bechtel BWXT Idaho, LLC

January 2004

ICP/EXT-03-00116 Revision 0 Project No. 23339

## In Situ Bioremediation Final Inspection Report

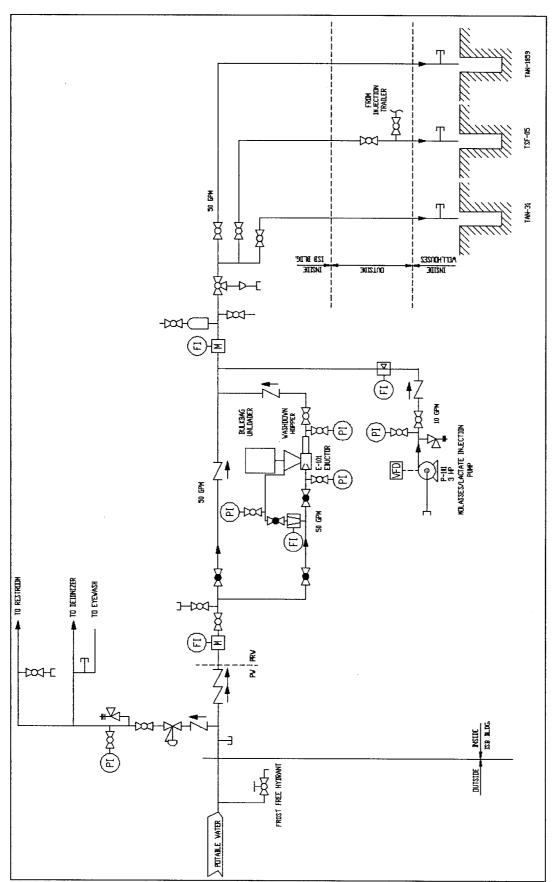
Figure 1. In Situ Bioremediation process flow diagram:

The first observation during these injections was that the lactate suction hose collapsed when trying to inject. This was caused by the high head capacity of the injection pump. Due to the requirements, a pump able to inject both molasses and sodium lactate was needed, but this also provides a lot of suction in the hose. To remedy this, a smaller hose and different adapter were used with no further difficulties.

The second observation was that the coriolis flow meter (FI-3) did not provide an accurate indication of amendment flow rate when compared with the estimated flow rate using a stopwatch. It was determined that the flow meter was defective and will be replaced. Until that can be accomplished, the variable frequency drive turned out to be a reliable method of flow rate control and will continue to be the method used for monitoring amendment injection flow rates.

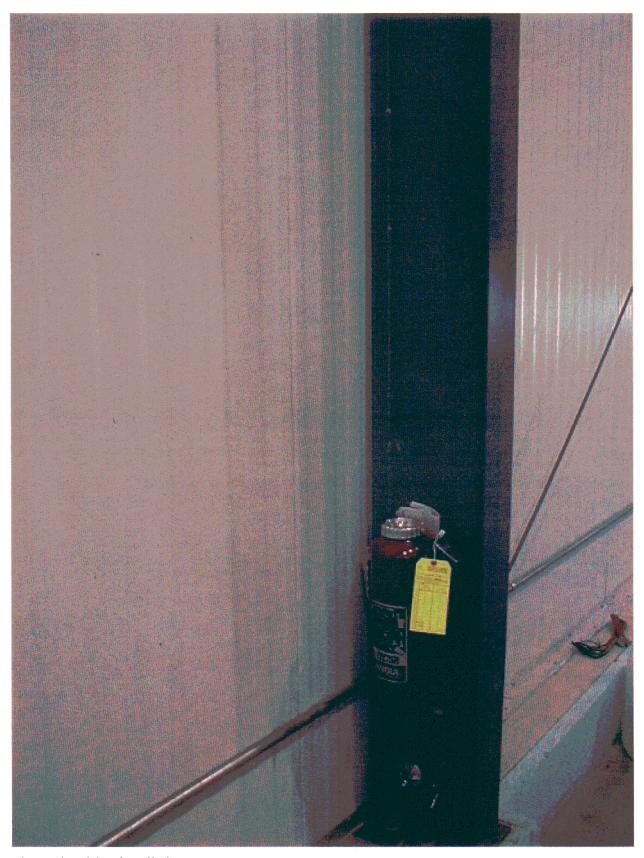
# Appendix D Fire Extinguisher Installation Photo

Inspection Checklist Item #	Issue	Resolution	Status
4.c	EPA 2: The fire extinguisher in process building inspection was not up to date.	The fire extinguisher will be mounted and a current inspection sticker will be attached (see Appendix D).	Complete

Fire Extinguisher Installation.
